Airmaster Propellers Ltd

SERVICE BULLETIN

APL-SB-13

**SUBJECT: ADDITION OF O-RING SEAL TO BLADE
RETENTION NUT TO PREVENT WATER
INGRESS INTO HUB**

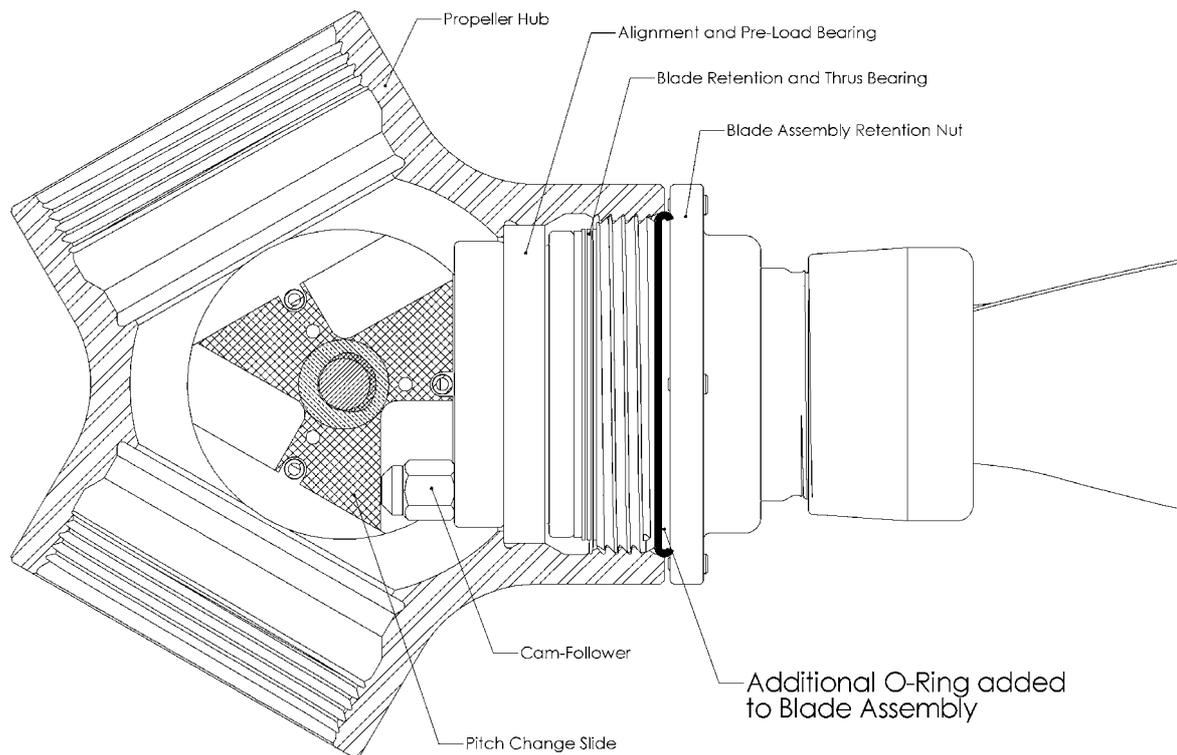
1. Airmaster AP308 propellers manufactured up to approximately February 2001 may suffer from water ingress while the propeller is stationary. Water, such as that from rain may enter the propeller hub via the large buttress thread that retains the blade assembly into the propeller hub.
2. This service bulletin addresses sealing of this water ingress route by the addition of an o-ring to the blade retention nut. The o-ring acts to seal between the blade retention nut and the propeller hub. The o-ring is fitted in the location shown in the following diagram.

Figure 1 - Blade Assembly Mounted in Propeller Hub showing Location of Additional O-Ring added to Blade Assembly

- a. Machine the propeller hub to provide a seat for an o-ring in each blade assembly mounting bore using the same CNC machine tool (a Mazak Integrex) that is used for manufacture of the propeller hubs.

- b. Modify each blade assembly to include an o-ring positioned around the blade retention nut. Depending on which revision parts are present, this may require that the blade assembly be re-set-up.
